RAHWAY RIVER BASIN  
WEST BRANCH RAHWAY RIVER  
ESSEX COUNTY  
NEW JERSEY

# CAMPBELLS POND DAM

**NJ 00517**

**PHASE 1 INSPECTION REPORT  
NATIONAL DAM SAFETY PROGRAM**

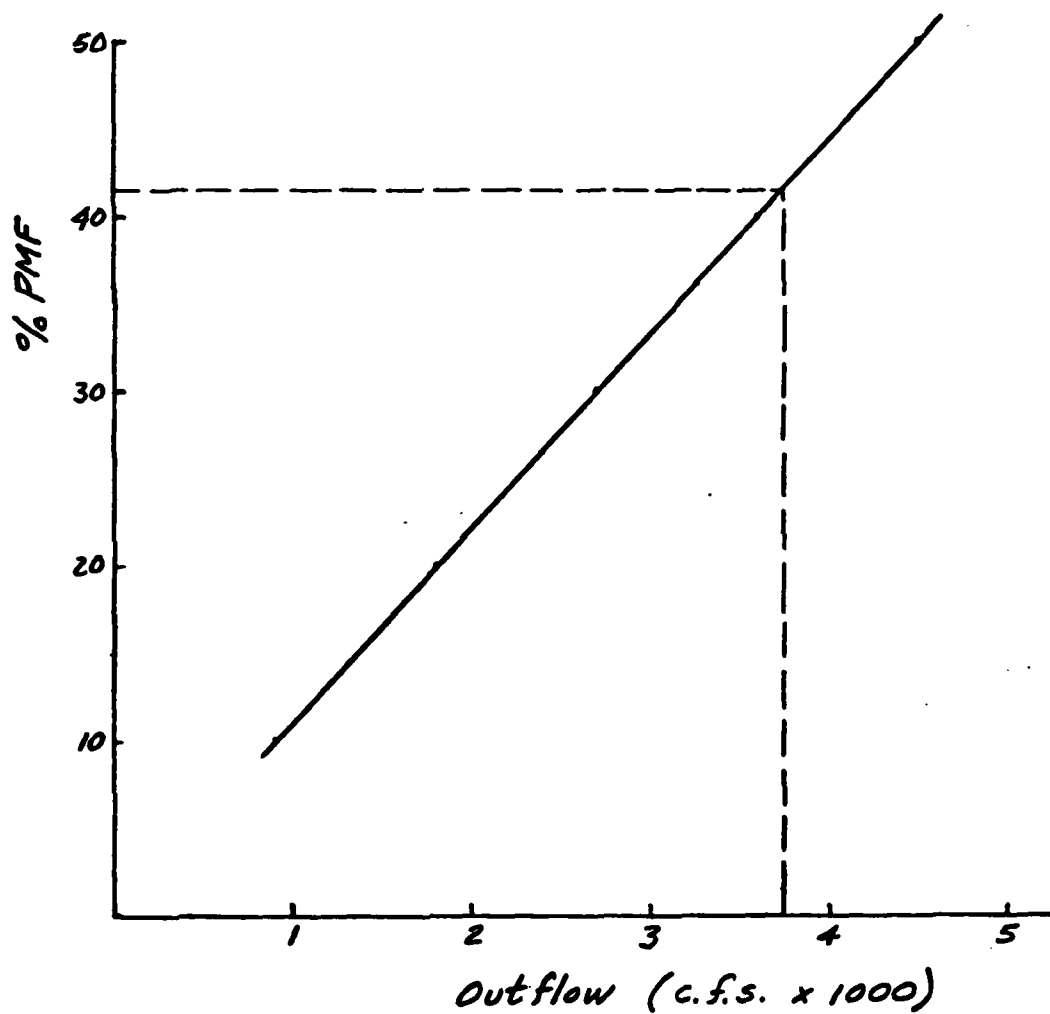
Overtopping Potential

Overtopping occurs at elev. 218.5  
with  $Q = 3748$  c.f.s.

$\therefore$  Dam can pass approx 42% PMF
